# Police Modifier Bulletin

## **SVE BULLETIN**

### **2013MY and beyond Utility Police Interceptor Vehicle Modifications and Sealing**

2013MY and beyond Utility Interceptors

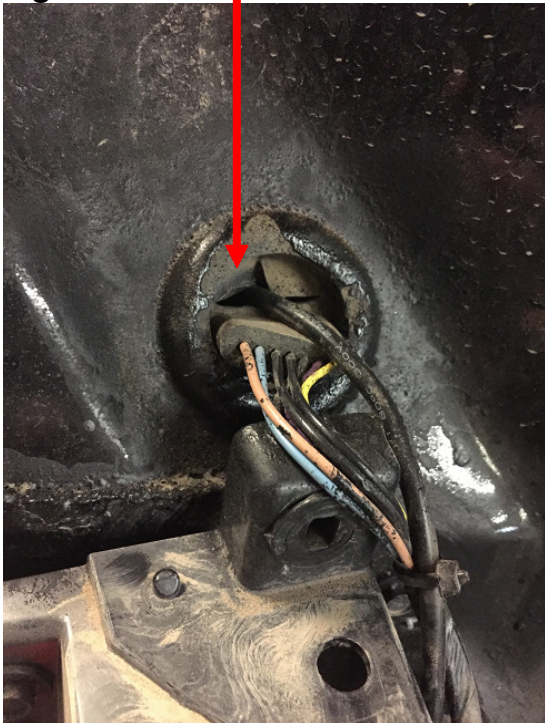
Figure 1

### Passenger Side Tail Lamp not properly sealed

- Any holes in the rear of the vehicle must be sealed
- Wiring pass-throughs, through sheet metal and/or existing grommets behind the passenger side and driver side tail lamps must be fully sealed using Motorcraft Seam Sealer (TA-2-B)

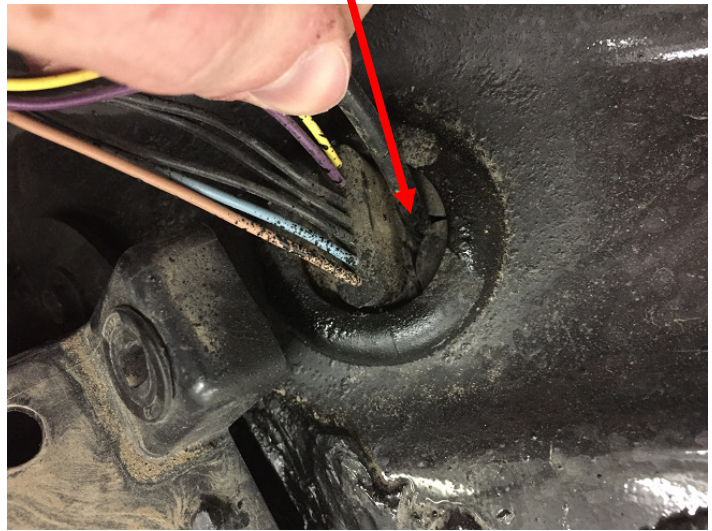
Figure 2

### Grommet not properly sealed
