# FORD HELPING POLICE DEPARTMENTS REPAIR MODIFICATION ISSUES IN POLICE INTERCEPTOR UTILITY VEHICLES

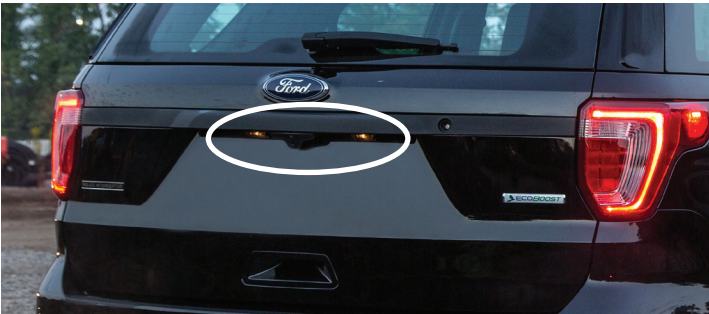
Police Interceptor Utility with factory-installed lights above license plate.

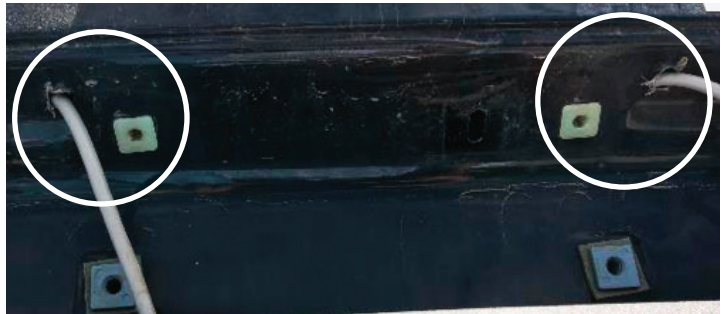
Factory-installed lights removed, with holes left uncapped. New holes added to accommodate after-market wiring.

check and seal off the rear of the vehicle where exhaust can enter from open holes or unsealed spaces

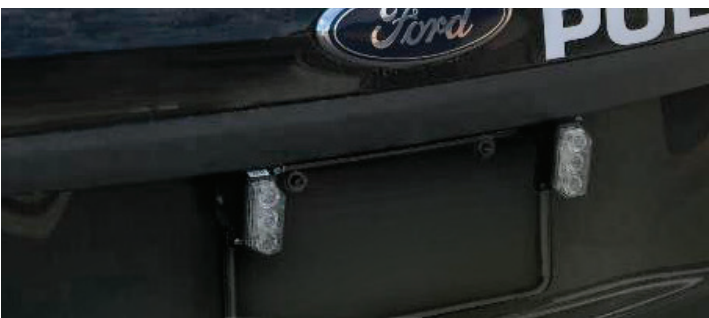
Police Interceptor Utility with after-market lights installed.
